Manhole Inspection Summary

Manhole # S15EE_028MH

Record Plat: **15EE** Node: **028** Status: **Not Found**

Insp Date: **7/31/09 9:56 AM**

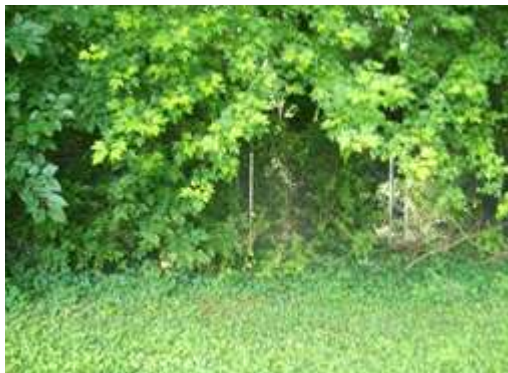
CNA – Manhole in CSX Right of Way, CCTV inspected and appears to be buried

PRIVATE RAIL ROAD PROPERTY C N A
